應用地質技師公會2021年度聯合會員(代表)大會

二十一世紀應用地質 的回顧與展望

27 March 2021

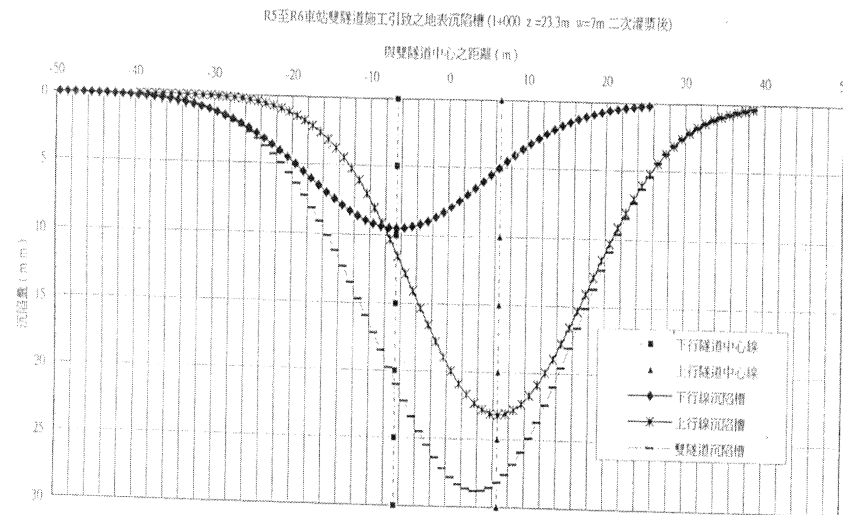
附圖 21 R5 至 R6 車站雙隧道施工引致之地表沉陷槽 (1+000 z=23.3m w=7m 二次灌漿後)

Superimposition of settlement troughs

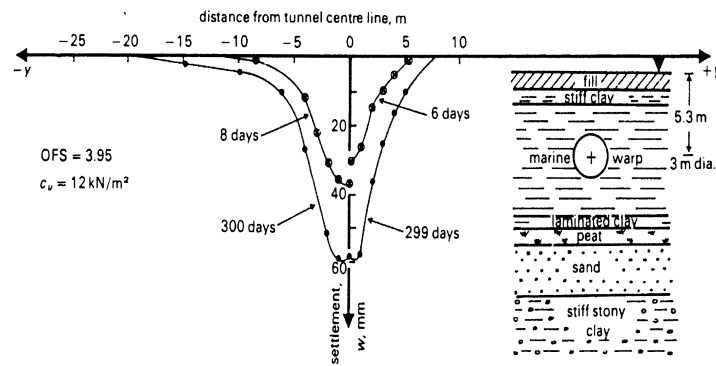
Figure 6.16 Transverse surface settlement distributions: Grimsby Array B1 (after Glossop, 1980; Glossop and O'Reilly, 1982).

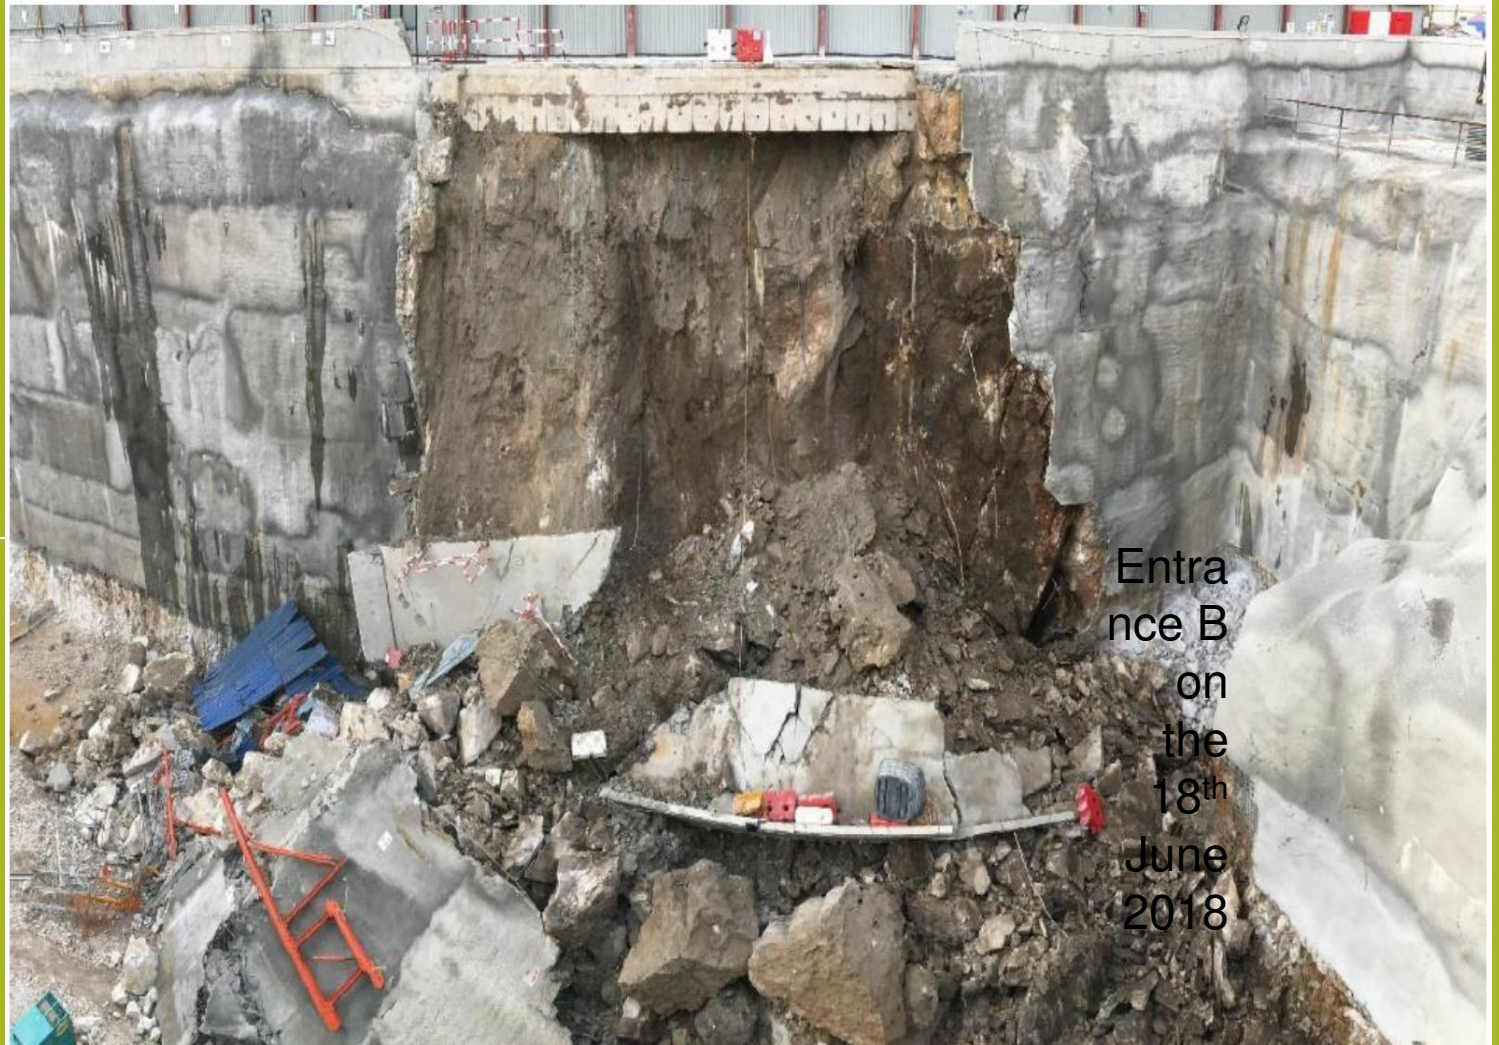
Example of localized rock slip due to unforeseen rock joint behind exposed rock face.

Despite extensive soil investigation and geophysics work were carried out, the risk is still unpredictable in karstic limestone.

Entrance B
on
the
18th
June
2018

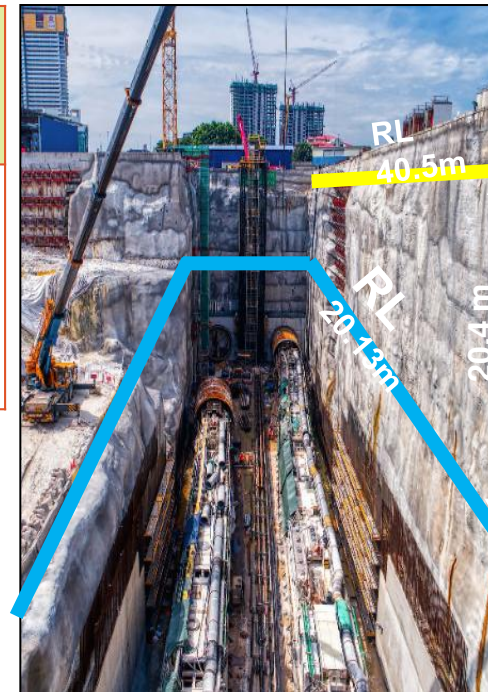
**Proposed 2 Level
Structural Completion
of Station Box**

**Structural Completion
until
Concourse Level Slab
Level**

- 1) After the completion of concourse slab, the remaining rock face height is still approx. 20m.

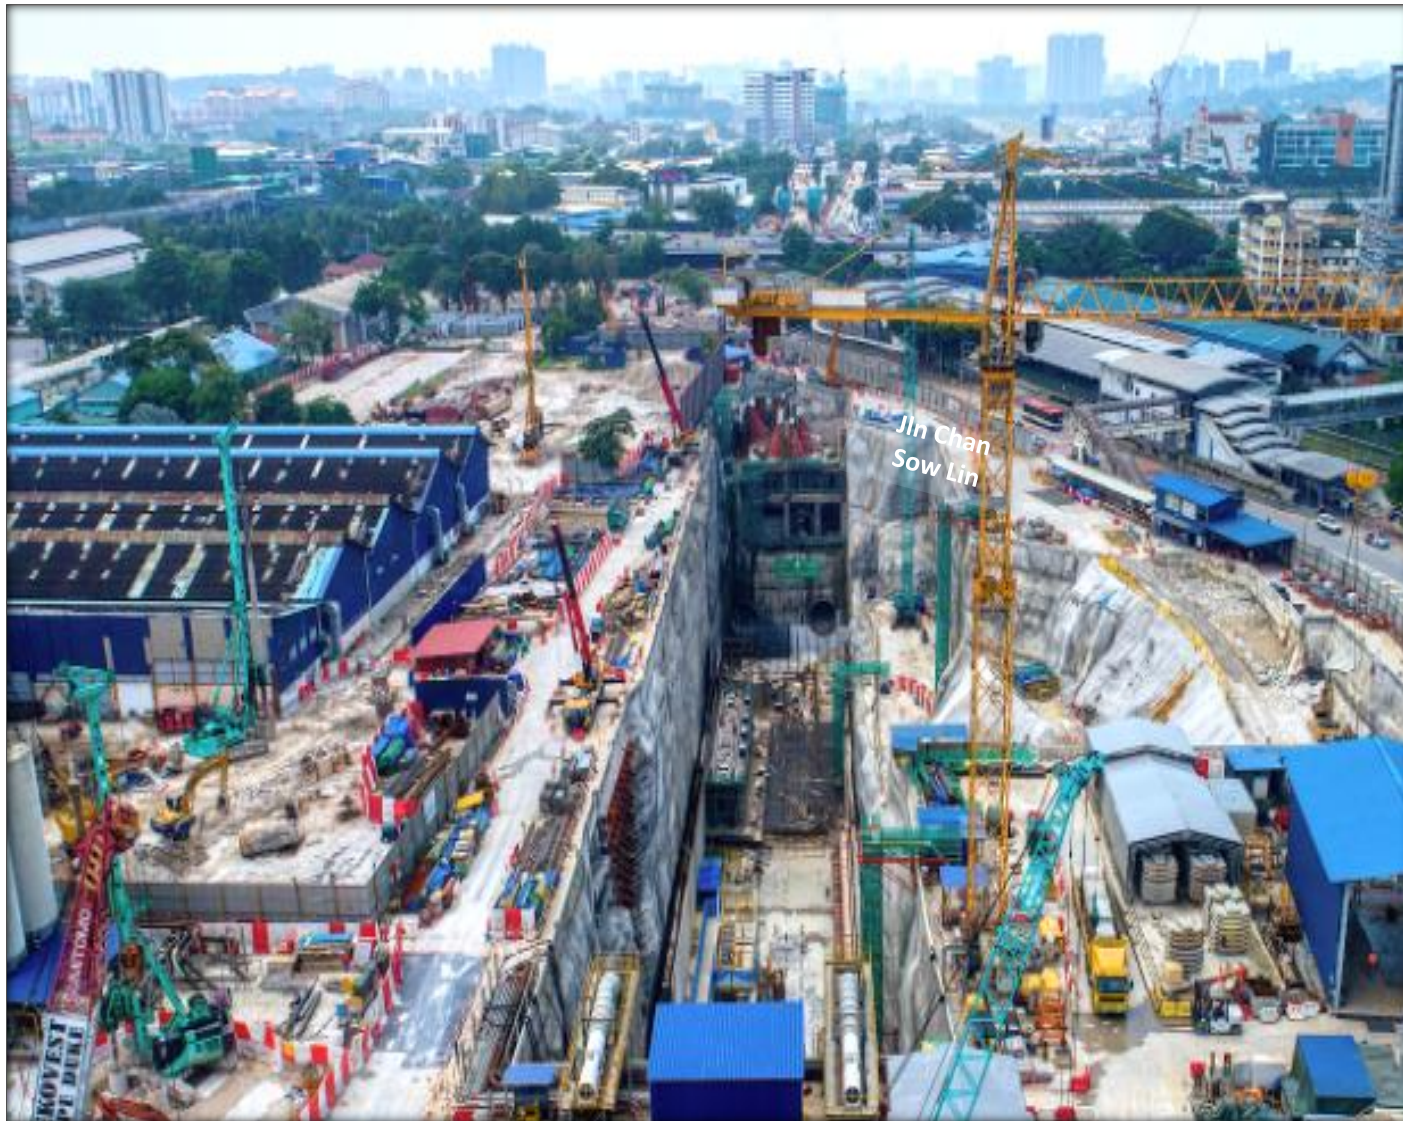
Digital scanning

- 數位化、科技化：1981 IBM-5150 PC >>> Wintel
 - GIS/BIM (Building Information Model)
 - 無人機掃描、測量 (Drone scanning/survey)
 - 機器人 (Robotics)：Sampling/Anchoring at seabed (>50m deep)
 - 遙控 (Remote control)：e.g. Automatic TBM operation
 - 地球物理探勘 (Geophysical exploration)
